Summary of the March 23, 2022 Hualien-Taitung Offshore Earthquake Event

1 - Introduction

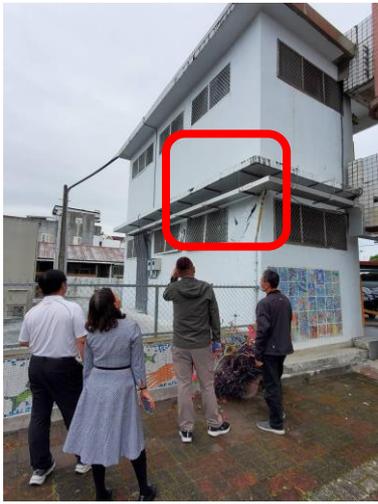
A stand-alone lavatory (Fig. 14) at Cheng-Gong Elementary School (CGES) in Taitung County located on the north side of the western school building close to the gate was damaged during the earthquake. Because the lavatory is not an area for learning activities, seismic evaluation and retrofit had never been performed. CGES is located 38.9 km from the epicenter of the earthquake (Fig. 15). The PGA recorded by the ChengKung strong ground motion station (1.16 km from the CGES) was about 567 gal (Fig. 16). After the earthquake, the office of the School Seismic Retrofit Project at the NCREE rapidly contacted the responsible person at every county government to collect information on the status of damage of school buildings across Taiwan. The damage to the lavatory was thus reported. Because of a short-column effect, the lavatory sustained shear cracks in the columns with a cover-spalling appearance (Figs. 17 and 18). In contrast, there was no serious structural damage to the eastern and western CGES buildings, which were built in 1988 and 1997, because their

Fig. 17 Appearance of the damaged CGES lavatory (source: Taitung County Government).

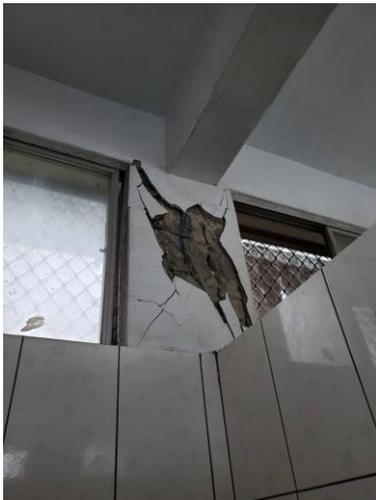
Fig. 18 Damaged short column of the CGES lavatory (source: Taitung County Government).

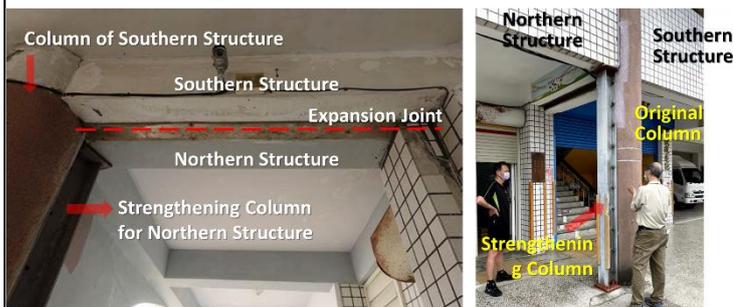
The western school building at CGES is a three-story reinforced concrete (RC) building with northern and southern parts separated by an expansion joint (Fig. 19). On the two sides of the expansion joint, there are existing RC columns. One RC column supports the southern part, and an added steel column supports the cantilever beam of the northern part, with the RC column and steel column side-by-side and connected with bolts. During this earthquake, the two columns collided with each other. As a result, the bolts at the top of the added steel column on the 3rd story fell away and were missing (Fig. 20).

Fig. 19 Expansion joint connecting the northern and southern parts of the western CGES building (PGA: 515 gal).

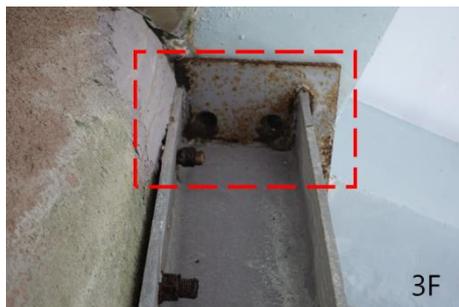
Fig. 20. Top bolts of the added steel column on the 3rd story that had fallen and were missing, CGES building (PGA: 515 gal).

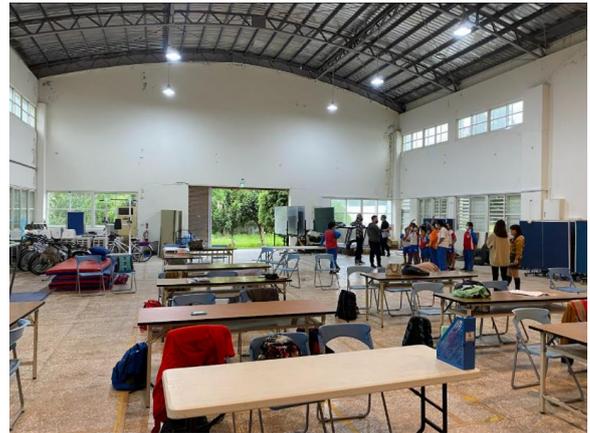
In the case of Zhongxiao (忠孝) Elementary School in Cheng-Gong (成功) Township, Taitung County, the southern school building was built in 1996 and the northern gymnasium was built in 1998. The school is 32.7 km away from the epicenter, and the PGA was estimated to be around 401 gal. The entrance of the gymnasium is on the eastern side of the building, which was seismically retrofitted with shear wall reinforcement. Figure 21 shows the inside of the gymnasium. The damage to the building caused by the earthquake includes a gap between the eastern wall and the roof (Fig. 22), horizontal cracks at the top corners of both sides of the door frame at the entrance (Fig. 23), and cracks with a maximum width of 5 mm on the ground of the gymnasium (Figs. 24 and 25).

Fig. 21 Inside the gymnasium at Zhongxiao Elementary School in Taitung County (PGA: 401 gal).

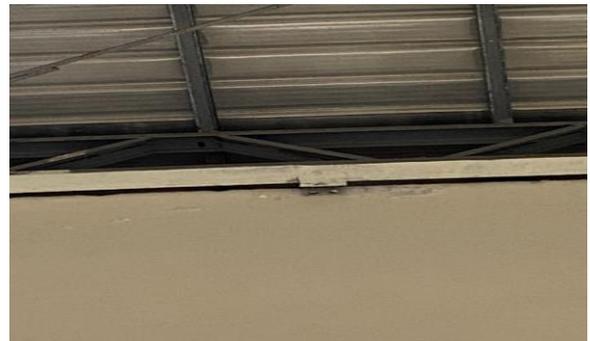
Fig. 22 The wall on the entrance side suspected of being inclined to the east, causing a gap between the wall and roof, Zhongxiao Elementary School (PGA: 401 gal).

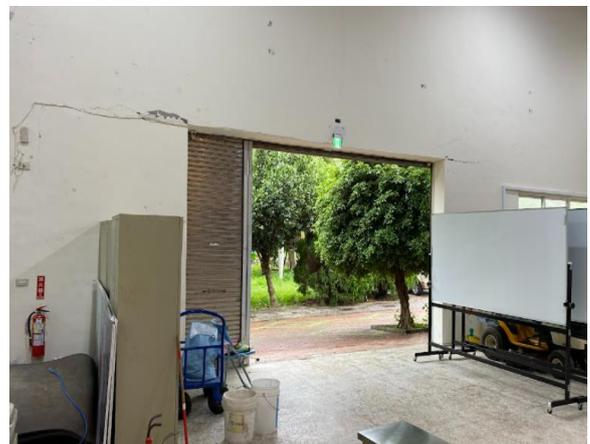
Fig. 23 Horizontal cracks at the top corners of both sides of the door frame at the entrance of Zhongxiao Elementary School (PGA: 401 gal).

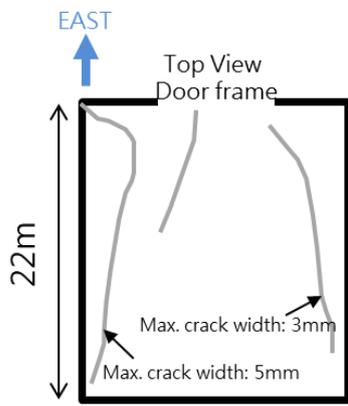
Fig. 24 Illustration of the cracks on the ground of the gymnasium, Zhongxiao Elementary School.

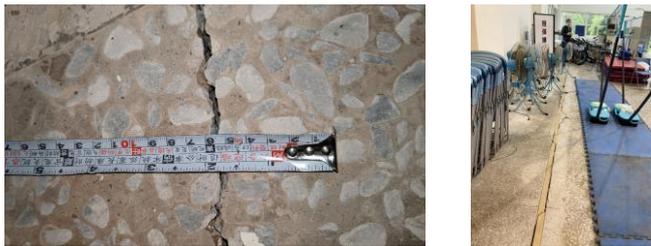
(a) Crack width

(b) Cracks on north side of the ground.

Fig. 25 Cracks on the ground of the gymnasium, Zhongxiao Elementary School (PGA: 401 gal).

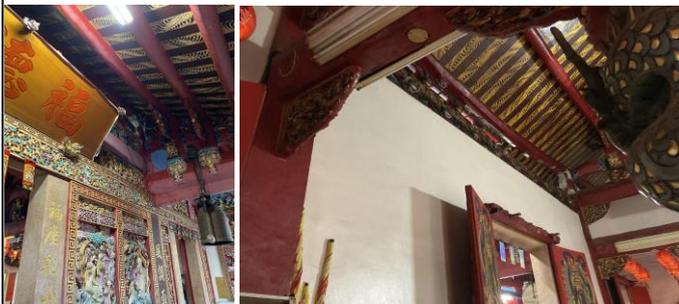
The Fude Temple (福德宮) in Cheng-Gong, Taitung County consists of three RC buildings built at different periods. The temple is 39.2 km from the epicenter, and the PGA was estimated to be 524 gal. The earthquake damage that occurred during this event was concentrated in the first building, particularly in the beam-column joints between the front door and roof (Figs. 26 and 27). The beam-column system supports the roof; however, the gable roof design results in a short column effect at the front and the back of the roof. Furthermore, the walls around the front door do not extend to the roof; instead, there are small statues between the roof and the beam above the front door. Therefore, the strength of the structure was suddenly reduced here, and the beam-column joints and statues above the front door were damaged during the shock. In addition, the diaphragms underneath the roof cracked in the southwestern and northeastern corners.

Fig. 26 Small statues instead of walls connect the roof and the beam above the front door of the Fude Temple, resulting in a sudden reduction in strength (PGA: 524 gal).

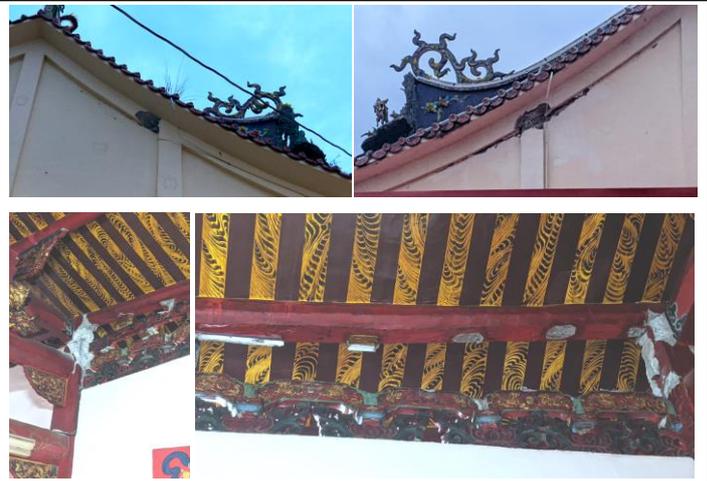
Fig. 27 Damaged beam-column joints underneath the roof and the cracked diaphragms, Fude Temple. The small statues between the beam and the roof fell apart to the ground (PGA: 524 gal).

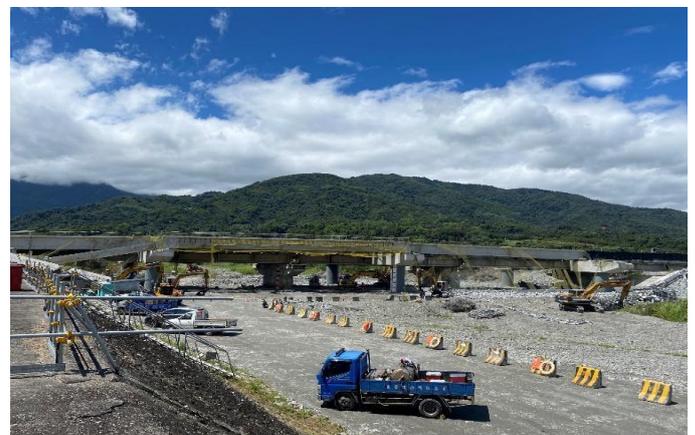
This widening project involved adding bridge columns and erecting prestressed beams. On the northbound line of the bridge, the prestressed beam was still under construction and the support had not been fixed. During the earthquake, collapse caused the prestressed beam and the back wall to slide relative to each other. On the southbound line, an elevated prestressed beam had been added, which fell into the main bridge lane when the earthquake struck, but fortunately caused no casualties. The original main bridge structural system had no abnormality in its expansion joints. The Directorate General of Highways has restricted bridge access and carried out demolition of the damaged prestressed beams.

Fig. 28 The east side of the Yuxing Bridge after demolition (PGA: 135 gal).

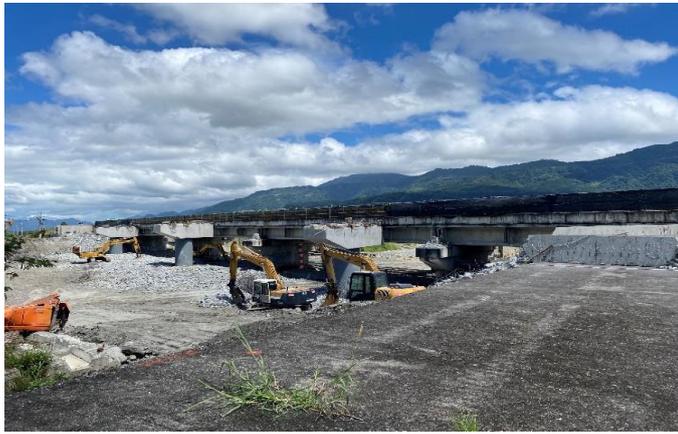
Fig. 29 The west side of the Yuxing Bridge after demolition (PGA: 135 gal).

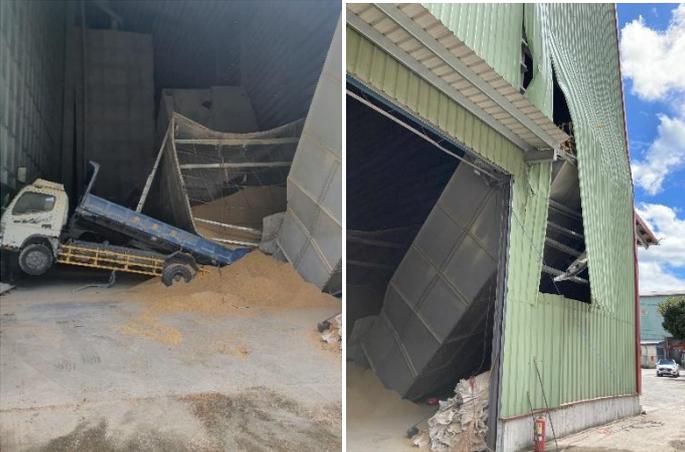
The grain storehouse of Nian-Chang rice mill (年昌碾米廠) in Yuli (玉里), Hualien County, was damaged in this earthquake. There were twenty-four 12-m-high grain tanks supported by 3-m-high steel frames inside the storehouse, and each tank weighs 200 tons when fully laden with grain. The first row of tanks collapsed westward during the earthquake, and collided with the storehouse structure and corrugated steel sheets. The southwestern corner of the storehouse is the working area for trucks, and two trucks were destroyed by the tanks (Fig. 30). The structure was deformed westward after the earthquake (Fig. 31). The columns between the overhead doors were tilted, and the doors were damaged due to grain pouring out of the structure. In addition, the roof was deformed during the movement of the exterior wall.

Fig. 30 The Nian-Chang rice mill 15-m-high grain tanks that collapsed westward and collided with the storehouse and trucks (PGA: 140 gal).

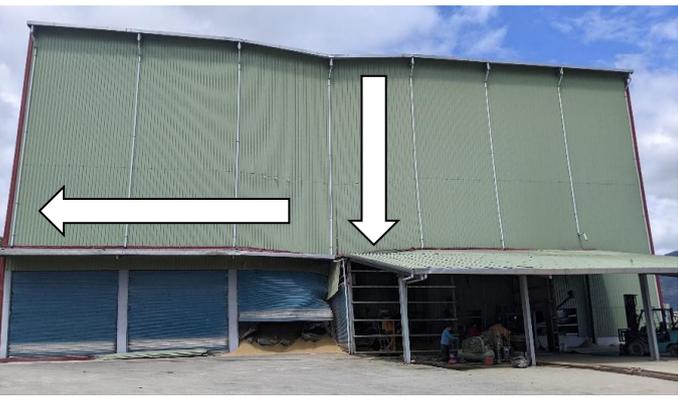
Fig. 31 Deformation of the Nian-Chang storehouse (PGA: 140 gal).

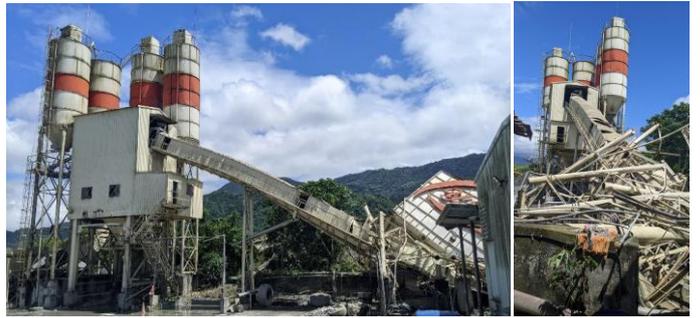
The Da-Yuan sand quarry (大元砂石場) is located alongside the Xiugulan River (秀姑巒溪) in Yuli, Hualien County and is approximately 22 km from the epicenter. Part of the processing equipment, including an approximately 18-m-high storage tower, conveyor belts, and supporting structures connected to the tower collapsed in the earthquake (Fig. 32). The storage tank was estimated to have contained 1200 tons of sand and gravel, and was supported on 12 tubular steel columns, 26 cm in diameter and 1 cm thick. Most of the columns ruptured neatly during the earthquake (Fig. 33). It is presumed that the strength of the columns was reduced due to rusting at the welding spots between the columns and the tank or base plates. The overturning force induced by the earthquake was so great that the structure ruptured from its weaknesses. Fortunately, nobody was injured in this accident.

Fig. 32 Da-Yuan quarry storage tank and conveyor belts that collapsed and deformed during the earthquake (PGA: 175 gal).

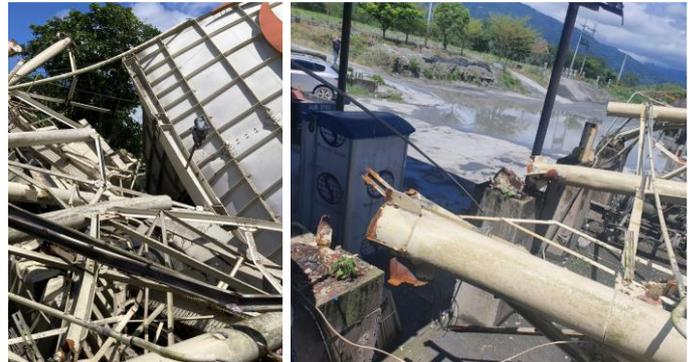
Fig. 33 Top and bottom ends of Da-Yuan steel columns that were ruptured neatly (PGA: 175 gal).

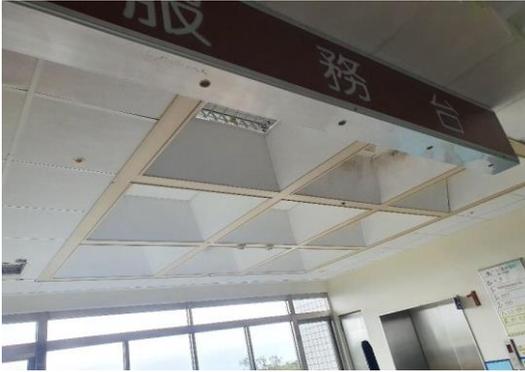
A type of specialty ceiling was constructed in the elevator lobbies at the Chenggong branch of Taitung Hospital (臺東醫院成功分院). This specialty ceiling is a combination of an exposed ceiling system and a hinted grid ceiling system (Fig. 34). The main failure pattern was identified to be due to the lack of proper connection strength between the ceiling grids and panels, which resulted in substantial collapse of the panels during the earthquake (Fig. 35). Another failure pattern,

Fig. 34 The specialty ceiling in the first-floor elevator lobby at Taitung Hospital (PGA: 535 gal).

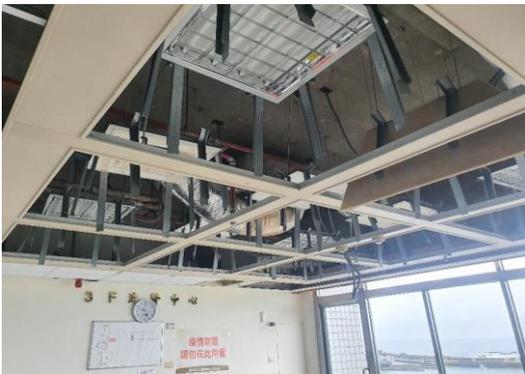
Fig. 35 The damaged specialty ceiling in the elevator lobby on the third floor of Taitung Hospital (PGA: 535 gal).

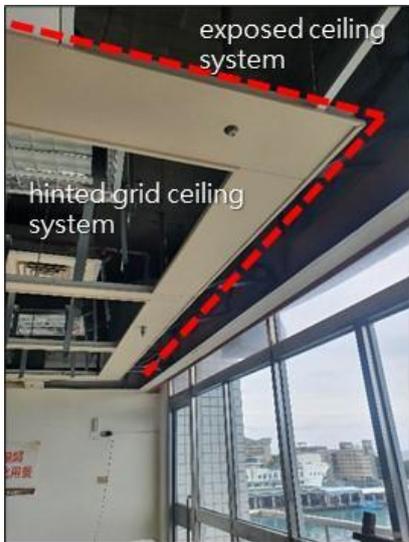
presented in Fig. 36, was observed at the interface of the exposed ceiling system and the hinted grid ceiling system. The ceiling grids and panels collapsed once there was relative movement between the two systems.

Fig. 36 Ceiling failure at the interface of the exposed ceiling system and the hinted grid ceiling system at Taitung Hospital (PGA: 535 gal).

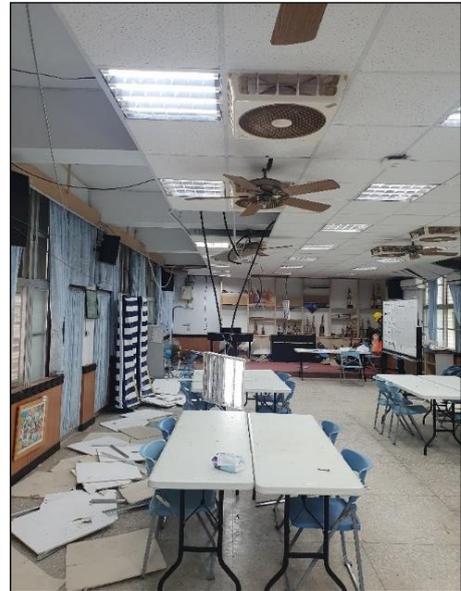
Exposed ceilings experienced widespread and extensive damage in this seismic event. The most serious damage to ceilings was observed at Zhongxiao (忠孝) Elementary School. Figure 37 shows severe damage suffered by the exposed ceilings. Light fixtures fell down, primarily due to the lack of proper seismic design and insufficient ceiling strength capacity. The connection latches of cross

Fig. 37 Damaged exposed ceiling at Zhongxiao Elementary School (PGA: 401 gal).

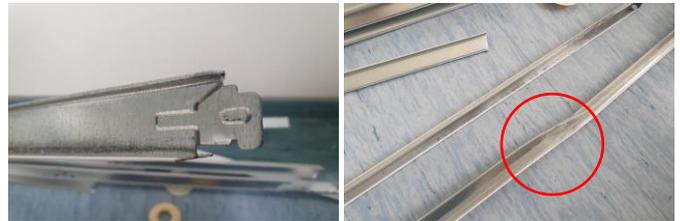
Fig. 38 Ceiling grid and grid connection failure, Zhongxiao Elementary School (PGA: 401 gal).

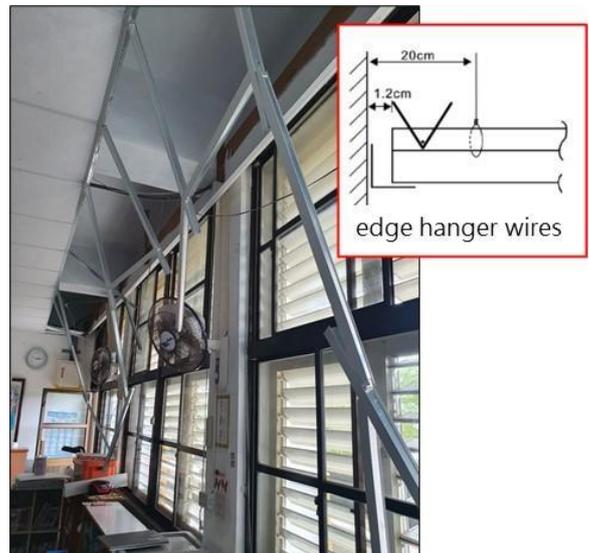
Fig. 39 Ceiling failure due to the lack of edge hanger wires, Zhongxiao Elementary School (PGA: 401 gal).

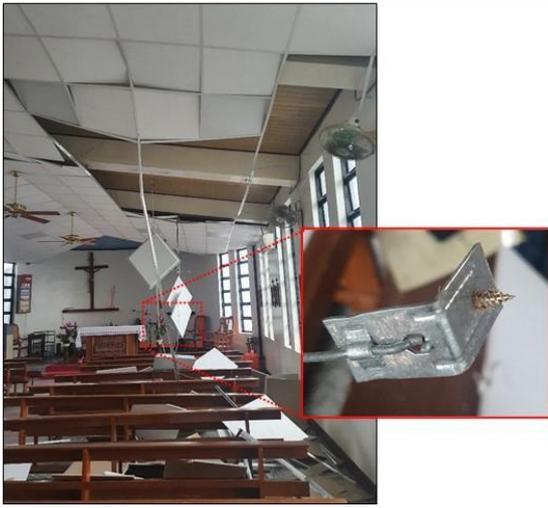
tees were pulled out and the grids were deformed visibly (Fig. 38). In addition, a common problem was the unseating failure of the ceiling grids where no edge hanger wire was applied in the ceiling installation (Fig. 39). Another damage pattern, classified as anchorage failure, was observed at Yong-Fu Presbyterian Church (永福基督長老教會天主堂). The damage was concentrated on the anchor device because of insufficient anchorage strength. The size of the screw was too short, so the suspension wires of the ceiling system could only be attached to the wood laths, and not to the floor structure above (Fig. 40).

Fig. 40 Damaged to exposed ceiling in Yong-Fu Presbyterian Church (PGA: 336 gal).

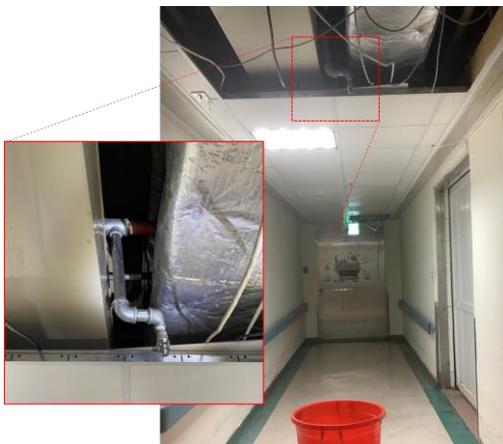
Past earthquakes experiences have shown that even minor damage to fire sprinkler piping systems can result in a substantial reduction in building functionality, which is primarily due to flooding caused by leakage from piping. Two main failure patterns were identified in this seismic event: failure of piping joints and failure of sprinkler heads. Figure 41 shows hydrant water leaking onto the fifth floor of the Chenggong branch of Taitung Hospital after the piping joint failed due to impact by the nearby overhead components. The sprinkler head was found to be damaged primarily due to the interaction between the sprinkler head and the specialty ceiling (Fig. 42).

Fig. 41 The damaged piping joint on the fifth floor of Taitung Hospital, Chenggong branch (PGA: 535 gal).

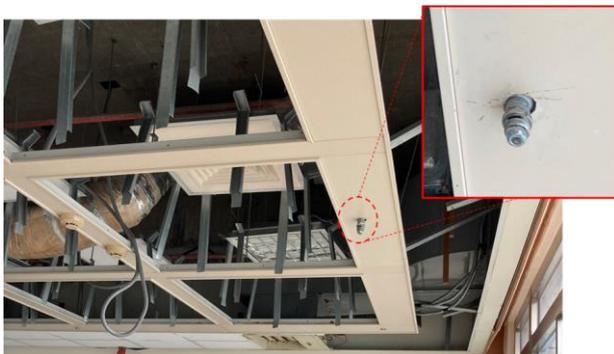
Fig. 42 Failure of the sprinkler head due to interaction with the ceiling, Taitung Hospital (PGA: 535 gal).

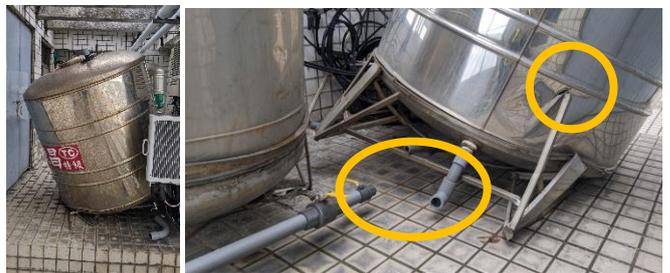
The water tank on the rooftop had a height and diameter of 1.5 m, and was supported on a steel stand consisting of four legs and a ring (Fig. 43). Three of the four legs were anchored to the floor, and the tank was placed on the ring. The unanchored leg survived but the other legs were all deformed due to broken welding joints or buckled members. As a result, the water tank tilted and buckled, and the pipe was broken as well.

Fig. 43 Tilted water tank due to failure of the stand underneath it, Taitung Hospital (PGA: 535 gal).

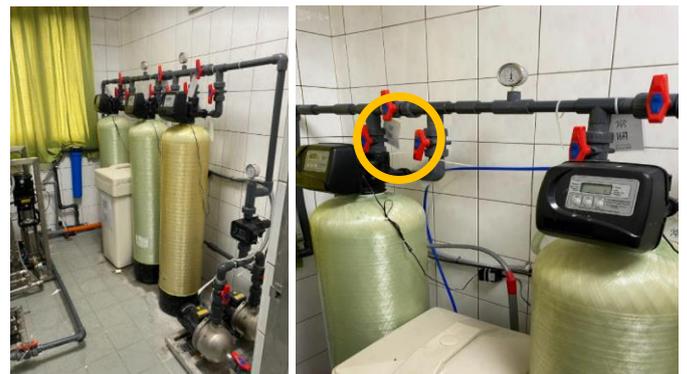
The Chenggong branch of Taitung Hospital set up an RO processing system on the third floor to purify water for kidney dialysis. Three 140-cm-high filter elements of the RO system were free standing on the floor, and were connected with each other through the UPVC pipes above the filter elements (Fig. 44). The pipe at the southeastern corner was sheared off during the shock and was repaired the day after the earthquake.

Fig. 44 The marked pipe was sheared off, Taitung Hospital (PGA: 535 gal).

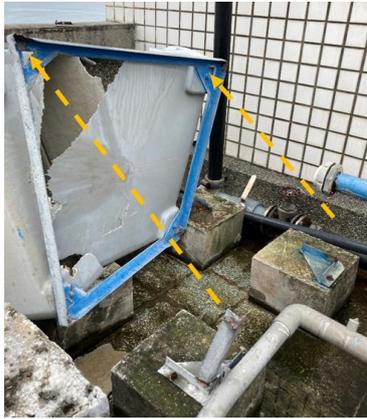
The fiberglass reinforced plastic (FRP) expansion water tank of the air-conditioning system anchored on the roof of the Chenggong branch of Taitung Hospital collapsed and was seriously damaged during the earthquake. The overturning of the FRP expansion tank also broke its water supply pipe, causing the entire air-conditioning system to shut down (Fig. 45). The mechanical and electrical manufacturers were carrying out repair work the next day, but the air-conditioning system had not yet resumed operation.

Fig. 45 Seriously damaged FRP expansion water tank on the roof of the Taitung Hospital, Chenggong branch (PGA: 535 gal).

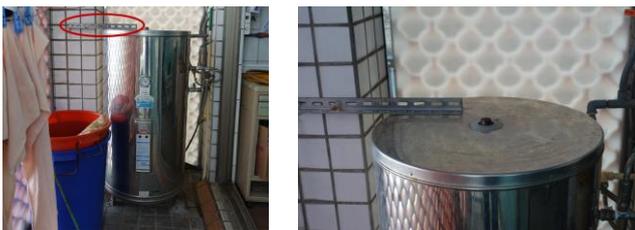
The free-standing water heater on the fifth floor of the Chenggong branch of Taitung Hospital was overturned due to the shock, which resulted in a broken pipe and loss of functionality. After the earthquake, the water heater was temporarily repaired and strengthened by attaching steel angle iron from its top to the nearby column (Fig. 46). The current strengthening method may not be helpful in supporting the weight of the heater; a fixed stand or base and supporting straps at the center of gravity of the heater are recommended (Fig. 47).

Fig. 46 The damaged heater, which was repaired after the earthquake and strengthened by attaching a steel angle iron at its top, Taitung Hospital. This is not a long-term solution for supporting the weight of the heater (PGA: 535 gal).

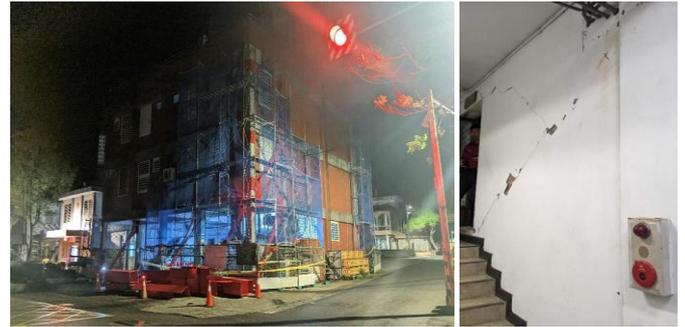
Based on the information on the emergency response center website of Taitung County, several non-structural walls in schools, fire departments, and hospitals were cracked in this earthquake. Part of the cracked walls in Dong-He (東河) and Lu-Ye (鹿野) Stations of the Taitung County Fire Department are shown in Fig. 48 and Fig. 49,

Fig. 48 Dong-He Station, Taitung County Fire Department being retrofitted. The brick wall outside the duty room on first floor was cracked, and the door got jammed (PGA: 409 gal).

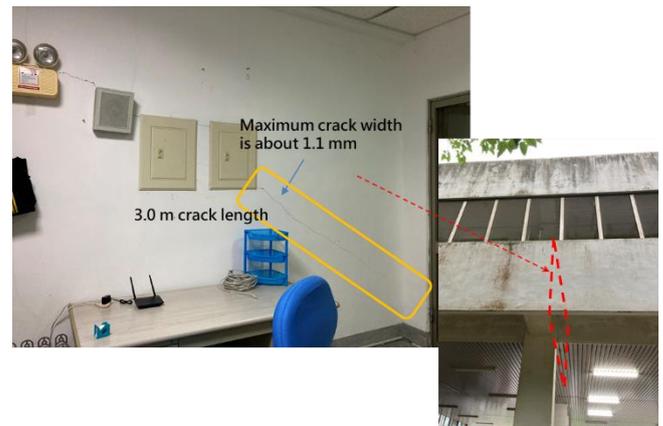
Fig. 49 A few of the partition walls on the second floor of Lu-Ye Station, Taitung County Fire Department were cracked (PGA: 53 gal.).

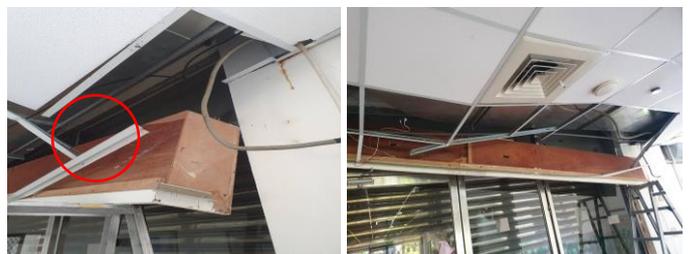
A fallen air-conditioning box was observed in the staff mess hall of the Yuli Hospital, the Ministry of Health and Welfare. This failure caused collateral damage to the suspended ceilings because the ceilings were physically connected to the air-conditioning box (Fig. 50).

Fig. 50 Failure of an air-conditioning box and suspended ceilings, Yuli Hospital (PGA: 135 gal).

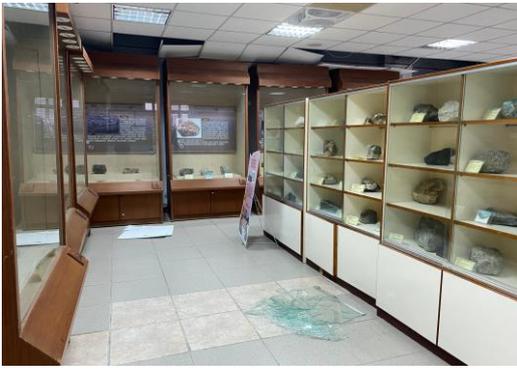
Broken showcase glass was observed at the Taitung County Museum of Natural History. This failure resulted from the large movements of the rock specimens inside the showcases, which impacted the glass (Fig. 51).

Fig. 51 Broken showcase glass at the Taitung County Museum of Natural History (PGA: 465 gal).
