## Reconnaissance and learning after the February 6, 2018, earthquake in Hualien, Taiwan

### Abstract

**Keywords** Seismic reconnaissance · 0206 Hualien earthquake · Milun fault · Near-fault ground motion · Building collapse · Bridge · Liquefaction · Non-structural component

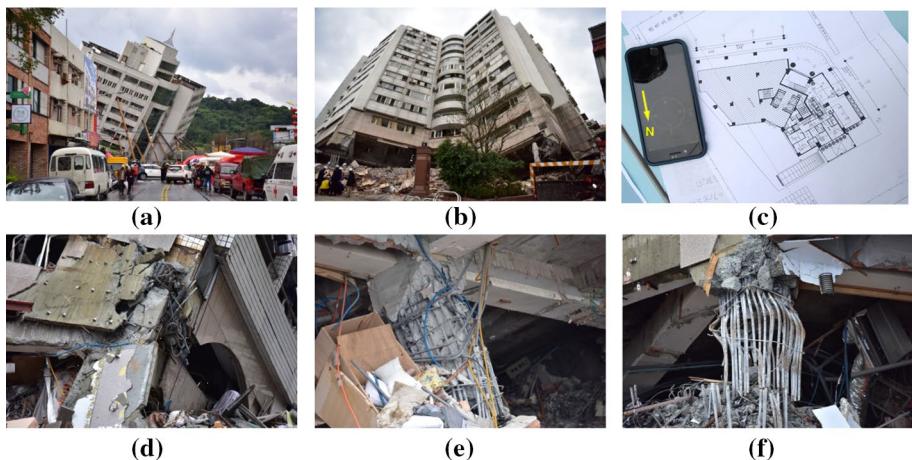
The collapse of this 12-story reinforced concrete (RC) building resulted in the severest number of fatalities, i.e., fourteen out of the total of seventeen in this earthquake. Figure 8a, b respectively show the front and rear sides of the collapsed building, which was built in 1994. The yellow steel struts shown in Fig. 8a are temporary measures to prevent the building from further collapse, which might threaten the lives of the rescuers. The floor plan of the building (Fig. 8c) indicates that the front of the building is to the south-west. In addition, the building is relatively plan-asymmetric. Due to the significantly high peaks of the E-W acceleration response spectra between 1.5 s and 2.5 s (Fig. 6), the building whose dominant vibration period was highly likely within the stated period range collapsed toward the front (i.e., the south-west direction). It is worth noting that the first and second stories of the building were commercially used as a hotel with large open spaces in its lobby/reception hall. Figure 8d–f show the damaged columns that had overly large spacing of stirrups, which was approximately equal to 25 cm to 30 cm. In addition, the splices of all the column reinforcements appeared at the same height (Fig. 8f), which was contrary to the

**Fig. 8** **a** Front view, **b** back view, **c** drawing of floor plan, **d** corner column, and **e** and **f** bottom columns of the collapsed 12-story mixed-use apartment block

current code requirements (CICHE 2011). Figure 8f shows that the column moved upward and failed where splicing of reinforcements was deficient.

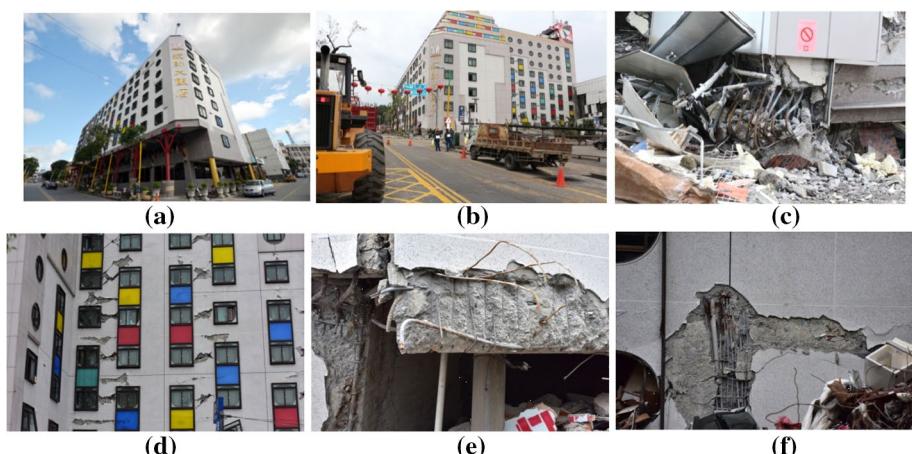
The collapsed hotel was built forty years ago, i.e., in 1978. Figure 9a, b show the appearances of the hotel before and after this seismic event, respectively. Except for the colorful peripheral slender columns, the building essentially overhung the second and above floors (Fig. 9a). After the seismic event, because the bottom two stories were completely crushed, the building appeared as if the third floor was at ground level (Fig. 9b). Because the bottom

**Fig. 9** Appearances of the hotel **a** before and **b** after the earthquake. **c** Crushed column, **d** shear cracks, **e** damaged beam, and **f** damaged beam of the collapsed hotel

story of this hotel had large open spaces used for reception, the number of RC walls of the bottom story were fewer than those of the other stories. Moreover, it was very possible that the seismic design and analysis of this aged building neglected the effects of partition walls, i.e., only the beam–column frame structure was considered. With this possible discrepancy between the actual building and the idealized analytical model, the presence of significantly different amounts of RC walls between the bottom story and the other stories very likely resulted in a soft-and-weak bottom story. In addition, without appropriate amounts of walls, the bottom columns probably sustained excessive axial loads during the earthquake. Figure 9c clearly shows that the columns' main reinforcements, which were confined with sparse stirrups, bulged outward, i.e., buckled. According to Fig. 9c, the spacing of the sparse stirrups appears to be greater than 30 cm. Because of the large width-to-height ratio of the building and because the bottom columns had deficient bearing capacities, the soft-and-weak bottom story eventually led to a “sit-down” type of collapse. In comparison, the collapsed 12-story mixed-use apartment (Fig. 8) had a smaller width-to-height ratio in the collapse direction (i.e., the south-west direction). In the light of Fig. 8c, the eventual collapsed form of the mixed-use apartment was a “knee-down” type (Fig. 8a). Perhaps, without the yellow steel struts (Fig. 8a), the mixed-use apartment might have been totally overturned during aftershocks. In such a case, the eventual collapsed form of the mixed-use apartment would be a “lie-down” type.

Figure 9d shows the inclined shear cracks of the exterior columns. Some of the shear cracks are cross-shaped, composed of two inclined cracks centered on one point. The column lengths shortened by windowsills (i.e., the deformations of columns restrained by windowsills) might be the main cause of the shear cracks occurring in the middle of the columns. Figure 9e indicates that the ends of the beams' bottom reinforcements were bent downward. In contrast, according to the latest suggestion of RC construction practice (CICHE 2011), the ends of the beams' bottom reinforcements should be bent upward into the connected columns to prevent damage to beam-to-column joints. Figure 9f depicts a damaged beam-to-column joint without sufficient numbers of stirrups in the joint.

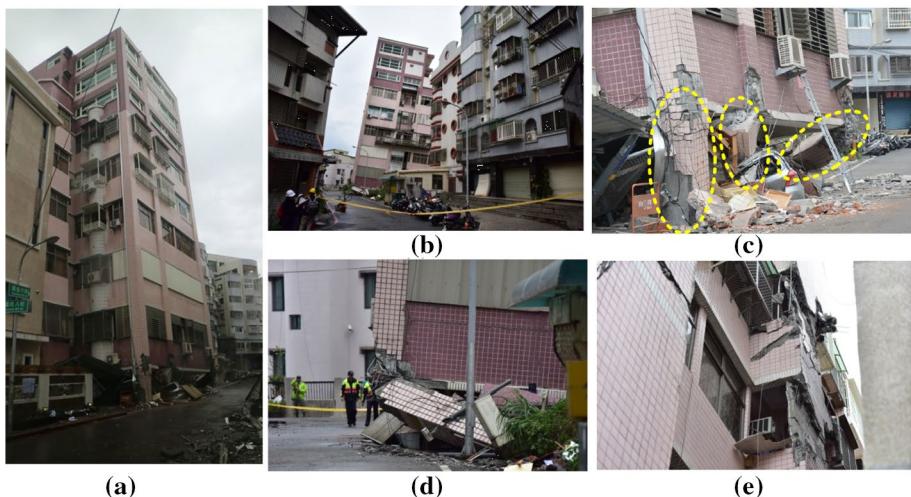
Figure 10a, b show the front and back of the tilted 9-story apartment building, which was built in 1994. Figure 10c is a close-up photograph of the bottom story shown in Fig. 10a. The bottom story of this building was used as a parking lot. Figure 10c indicates that there were two spans (i.e., three columns) along the direction shown in the photograph. The front, middle, and back columns circled in yellow were all bent at their tops. In addition, all

**Fig. 10** **a** Front and **b** back views of the collapsed 9-story apartment building. **c** and **d** Close-up photographs of the bottom story shown in **a** and **b**, respectively. **e** Exterior walls of the collapsed building

three columns were inclined toward the inside of the building, and the inclinations sequentially increased from the front column to the back column (Fig. 10c). As a result, the extent of the damages at the tops of the three columns sequentially increased from the front to the back columns. In detail, the top of the front column remained joined to the upper column. In contrast, the top of the middle column was almost entirely separated from the above column. Additionally, the surface of the break at the top of the middle column appeared smooth and there appears to be almost no reinforcements going through that surface. The back column, which was the most severely damaged among the three columns, was almost laid down as a rigid block. The back column shown in Fig. 10c can also be seen from the rear side of the apartment building shown in Fig. 10b, d. Figure 10d is a close-up photograph of the bottom story shown in Fig. 10b. Figure 10d indicates that the back column remained essentially intact except that the column's top was broken. The reinforcements and stirrups at the top portion of the back column were insufficient (Fig. 10c). Additionally, the concrete in the core of the back column appeared inferior, lacking proper cementation. Moreover, the appearances of the 2nd-story columns atop the three 1st-story columns were all torn off at different lengths and this sequentially increased from the front column to the back column (Fig. 10c). From Fig. 10d, the ends of the reinforcements of the beam connected to the back column were bent downward. Similarly to the discussion associated with Fig. 9e, the bending direction for the ends of the bottom reinforcements of the beams is upward rather than downward. Figure 10e shows the broken exterior walls and the detachment of the exterior tiles of the 9-story apartment building. From the broken section of the exterior walls, there seem to have been very few reinforcements in the exterior walls.

In light of the above-mentioned substantially unequal inclinations and damage extents of the three bottom columns shown in Fig. 10c, the frame consisting of these three columns very likely underwent rotation-induced out-of-plan displacements. In other words, the apartment building was probably plan-asymmetric, which had stiff and flexible sides at the front and back columns of Fig. 10c, respectively. In addition, according to the situations of the reinforcements and concretes exposed at the tops of the bottom columns,

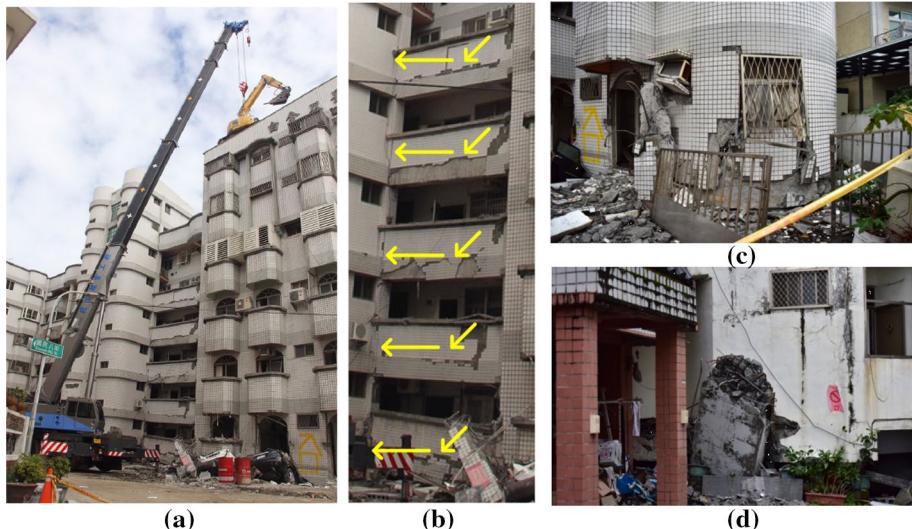
Figure 11a shows the collapsed 6-story apartment building, which was within an approximately 1-min walking distance from the aforementioned 9-story building (Figs. 7 and 10). The collapsed 6-story apartment building was constructed in 1992. Unlike the 9-story building (Fig. 10), which had a knee-down collapse, the bottom story of this 6-story apartment building (Fig. 11a) was also used as a parking lot and it displayed a sit-down collapse. This implies that the bottom-story parking lots with their open spaces and fewer partition walls caused soft bottom stories and this led to the collapse of the building. Furthermore, the possible translation–rotation coupled displacements of the 9-story building (Fig. 10) resulted in a knee-down collapse, such that the damages to the columns were unevenly distributed (Fig. 10c). In contrast, the sit-down collapse of the 6-story building (Fig. 11a) implies that the displacement demands of its bottom columns were approximately equal, i.e., only translational displacements occurred.

The central part of Fig. 11a (the exterior walls of the balconies of all stories) are magnified in Fig. 11b for clarity. These exterior walls have similar patterns of cracks, as indicated

**Fig. 11** **a** Front view of the collapsed 6-story apartment building and **b** a magnification of the central part of **a**. **c** Front and **d** back close-up photographs of the collapsed building

by the yellow arrows shown in Fig. 11b. In detail, each of these cracks started at the top right corner of the exterior wall of the balcony and then propagated left and downward with an approximate 45° inclination. Once the crack touched the top surface of the slab of the balcony, it propagated continuously and horizontally to the left side of the balcony. This pattern of cracks implies that the shear force was transferred at the right sides of the balconies. Additionally, there were weak junction surfaces between the slabs and the walls of the balconies. Figure 11c, d show the front and back walls of the apartment building on the ground. While the building settled, there should be substantial vertical reaction forces. The iron-grated window shown in Fig. 11c, which was a weak region of the wall, was extruded outward. The form of the flaked concrete extending out of the wall shown in Fig. 11d was similar to that of the window shown in Fig. 11c. This might reflect that the flaked concrete was a weak region of the back wall. Therefore, it is unsurprising to find that the quality of the concrete exposed at this weak region was poor (Fig. 11d).

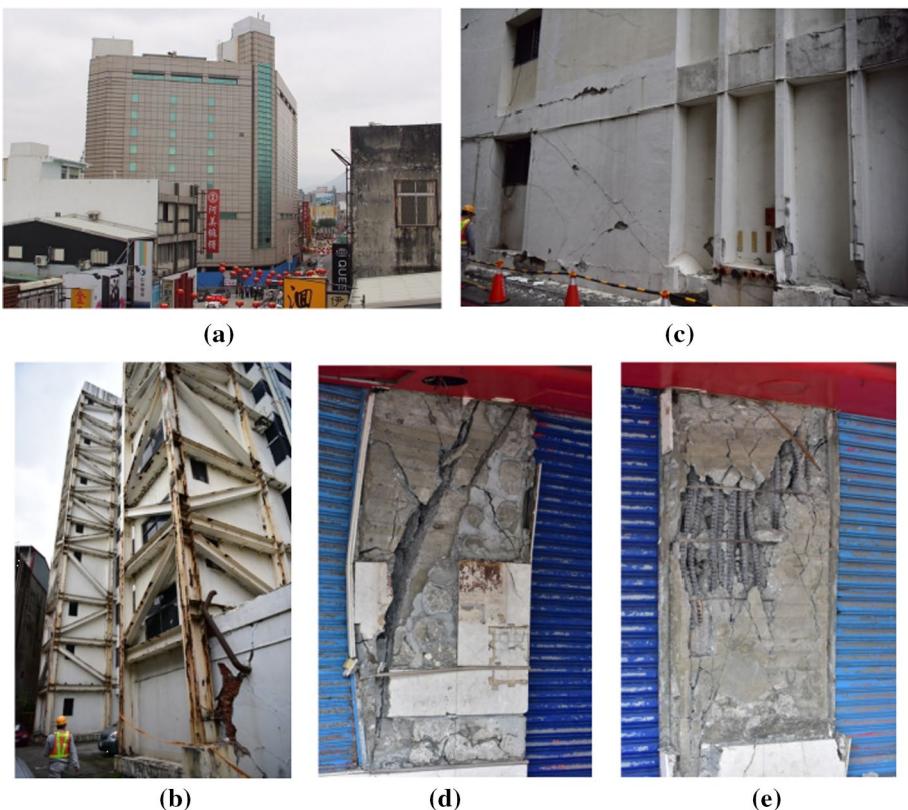
The damaged 12-story department store (Fig. 12a) was opened in 1991. After being damaged during the 1999 Chi-Chi earthquake, the department store was once repaired and retrofitted. The department store was moved to another building in 2009. Hence, the building was abandoned and empty when the 2018 Hualien earthquake occurred. The staircases at the back of the building were retrofitted with steel braced frames after the 1999 Chi-Chi earthquake (Fig. 12b). The staircases and the added steel braced frames remained essentially intact after the 2018 Hualien earthquake. In contrast, a brick wall appearing at the right bottom corner of Fig. 12b was cracked. This might imply that the added steel braced frames performed well such that the building was protected to some extent. Figure 12c shows that the lateral walls of the building were damaged with diagonal shear cracks. Moreover, the exterior columns of the bottom story shown in Fig. 12d, e were severely damaged with a deep and wide shear crack and a flexure-shear crack, respectively. The spacing of the stirrups shown in Fig. 12e was extraordinarily large, which was approximate 25 cm. Additionally, most of the decorated white stone panels encasing the columns had flaked off (Fig. 12d, e). The severely damaged building (Fig. 12) was eventually demolished after the Hualien earthquake.

**Fig. 12** Photographs of the damaged 12-story department store: **a** overall view, **b** retrofitting with a steel braced frame, **c** side view, and **d** and **e** severely damaged bottom columns

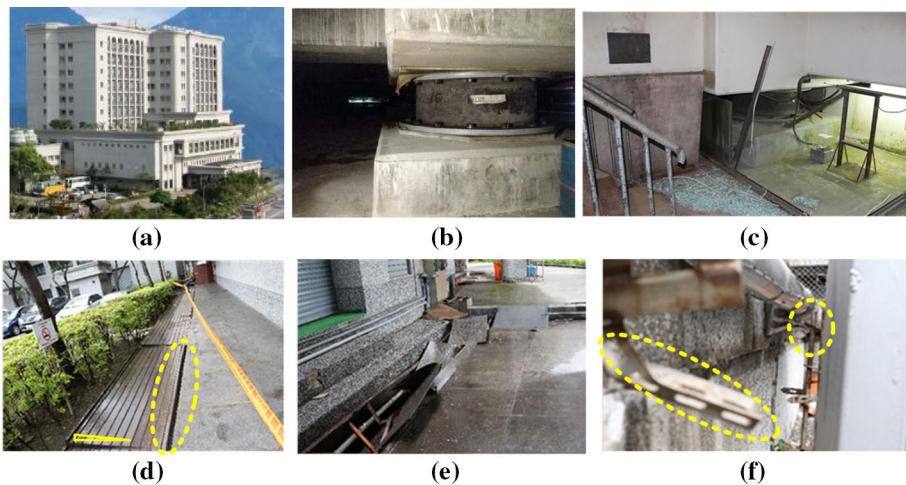
The base-isolated building is a regional hospital with ten floors and two base floors (Fig. 13a) located approximately 2 km away from the Milun Fault. The second base floor, abbreviated as B2F, is dedicated to installation of the isolators, which are lead rubber bearings (LRB) (Fig. 13b). There were no structural damages found in the building as a whole, including the isolators and the upper structure. Nevertheless, damages to some non-structural components were observed (Fig. 13c–f). Figure 13c shows the broken glass that was used for protecting and encasing the displayed seismic instruments. The reserved gap allowing lateral deformations of LRBs is 70 cm. The planks covering the reserved gap were inclined and pushed aside, leaving a space between the planks and the pavements of walkways (Fig. 13d). Some other segments of the reserved gap were covered using checker plates (Fig. 13e), which were damaged and disordered. Additionally, Fig. 13f shows damaged piping supports. Besides the seriously deformed piping support indicated on the left of Fig. 13f, the end of the right piping support was detached from the pipe (Fig. 13f). Although these non-structural damages did not affect the operation of the hospital, it shows that more attention to the details of non-structural components of buildings with seismic isolators is needed in comparison with conventional buildings.

**Fig. 13** Photographs of **a** the base-isolated building, **b** a lead rubber bearing, **c** broken glass, **d** gaps induced by the deformation of isolators, **e** damaged checker plates, and **f** damaged piping supports

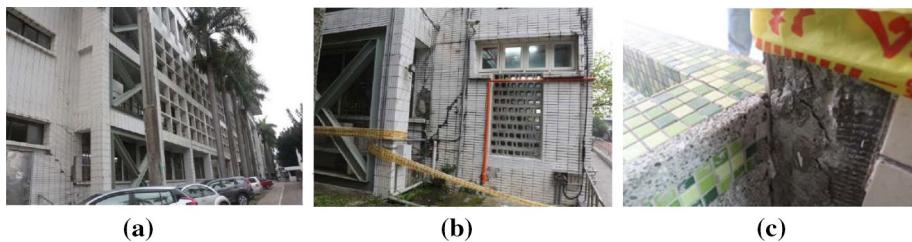
**Fig. 16** **a** and **b** Cracked brick walls. **c** A cracked column of a four-story school building

Figure 16a, b show the cracks in brick walls surrounding the lavatories of a four-story school building that was retrofitted with steel braces and had shear walls added in 2010. Figure 16c shows the cracks induced by pounding between a column and a sink in the other school building. The cracked column and the basin were from one two-story building and one four-story building, respectively. The two- and four-story buildings, which were built in 1984 and 1997, respectively, were arranged in an L-shape and separated with expansion joints. The basin was added to the second floor of the four-story building during the seismic retrofit conducted in 2014. However, there were no reserved gaps between the sink and the column. Because of the different vibration periods of the two buildings, the collision between the sink and the column during ground shakings was inevitable.

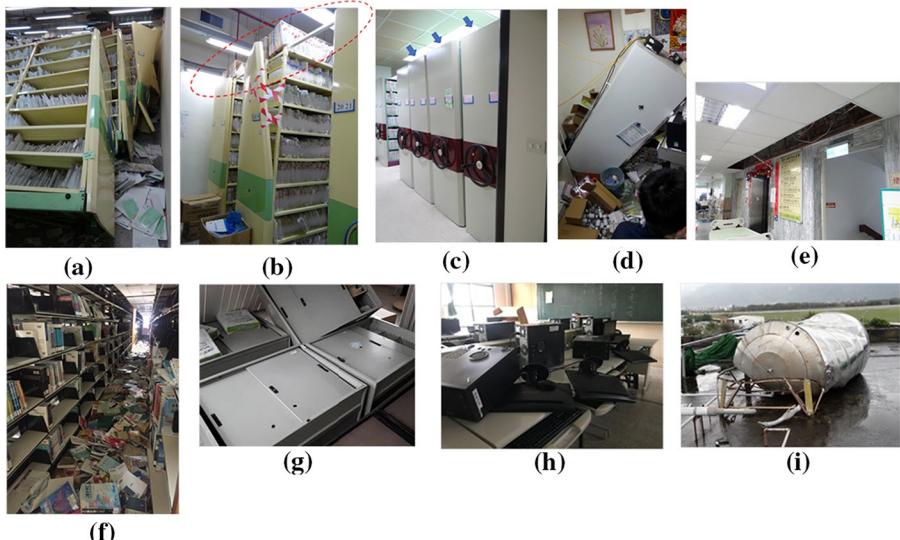
Besides damages to building structures, the damages to non-structural components of buildings are also discussed. Figure 18a–c show the different extents of damage to shelves of medical history sheets in a hospital. The shelves shown in Fig. 18a, b were identical and were moveable on their own wheels. Nevertheless, the countermeasures adopted for resisting seismic forces on the shelves were different. The shelves of Fig. 18a were fixed to the floor slabs via angle steels connecting the shelves' bottoms and the floor slabs with bolts. In contrast, the shelves of Fig. 18b were connected to each other via the links at the shelves' tops. Because of the insufficiency of the bolts connecting the shelves' bottoms and the floor slabs, the shelves in Fig. 18a were overturned. In contrast, because the added top links substantially increased the width-to-height ratio of the shelves, the only damage to the shelves in Fig. 18b was warped sideboards. The shelves shown in Fig. 18c were of another type that was moveable on sliding rails mounted on the floor slabs. Only some sideboards of the shelves shown in Fig. 18c were slightly inclined. It was also noted that the normal

**Fig. 18** a–c Damaged shelves for medical history sheets in a hospital. d An overturned medicine refrigerator. e Fallen ceilings in a hospital. f Books fallen from bookshelves. Overturned g filing cabinets and h desk computers. i A damaged water storage tank

vectors of the vertical planes of the shelves shown in Fig. 18a, b were in a NE-SW direction that was almost in line with the direction of most of the velocity pulses observed in the Hualien earthquake (Fig. 3). In other words, the velocity pulses were essentially along the short direction of the shelves shown in Fig. 18a, b. In contrast, the direction of the shelves shown in Fig. 18c was 90° rotated relative to the shelves shown in Fig. 18a, b. In other words, the velocity pulses were essentially along the long direction of the shelves shown in Fig. 18c. In addition, in light of the reserved large spacing between the shelves (Fig. 18a), a domino effect might be one of the reasons causing the overturning of a series of shelves, as shown in Fig. 18a. In contrast, the close spacing between the shelves shown in Fig. 18c might prevent the occurrence of a domino effect.

The other damages to non-structural components commonly observed in hospital buildings were the overturning of medicine refrigerators (Fig. 18d) and the fall of ceilings (Fig. 18e). The fallen ceilings shown in Fig. 18e were in front of the doors of elevators and the entrance to stairs. It is worth noting that no matter what the categories of the buildings (hospital, school, etc.), most of the falls of suspended ceilings occurred at the peripheral parts of the ceilings. This implies that possible collision between the suspended ceiling and its surrounding structural members (e.g., beams, walls) should be one of the main concerns of the seismic design of such ceilings.

Typical non-structural damages to schools during this seismic event were books falling from bookshelves (Fig. 18f), the overturning of filing cabinets and desk computers (Fig. 18g, h), and damaged water storage tanks (Fig. 18i). Figure 18i shows that the supporting frame of an overturned water storage tank was significantly deformed. This type of water storage tank, made of aluminum, is commonly installed on the roofs of buildings across Taiwan. Nevertheless, their supporting frames seem not to be differentiated for the different heights of buildings. In other words, the supporting frames are sold as accessories to the sets of water storage tanks rather than customized products. Therefore, it appears necessary to establish rational commercial codes or standards for such water storage tanks.

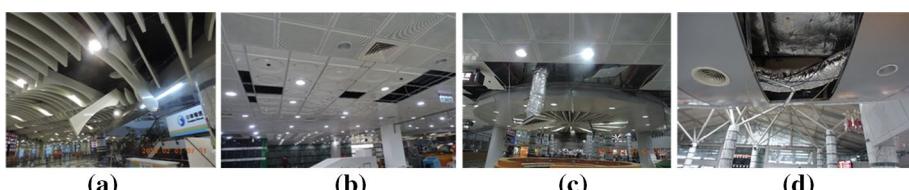
In addition to hospitals and schools, a terminal of an airport (Fig. 19) located approximately 1 km away from the Milun Fault was also examined after the earthquake. This terminal had three floors and one basement floor and was constructed in 2004. The baffle boards (Fig. 19a) and the ceilings, made of punched aluminum plates (Fig. 19b), had fallen during the earthquake, even though the terminal was relatively new. Figure 19c shows a ventilation duct hanging through the hole where the ceilings fell. The damaged sprinkler pipe for firefighting (Fig. 19d) resulted in the leakage of water in the arrival hall.

**Fig. 19** **a** Fallen baffle boards, **b** fallen metal ceilings, **c** a ventilation duct hanging through the hole where the ceilings fell, and **d** a damaged sprinkler pipe used for fire-fighting in an airport terminal

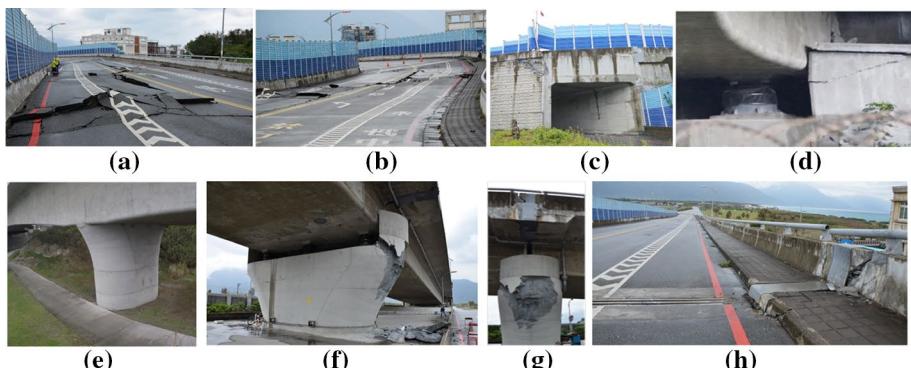
Figure 23a, b show the upheaval of the road embankment approaching abutment A2. In light of the displacements of the land surface shown in Fig. 21b, d, there was a thrust from the embankment toward abutment A2, by which the aforementioned upheaval was manifested. Additionally, that is why the noise barriers at the top of the upper-left corner of the culvert were pushed against each other (Fig. 23c). Figure 23d shows the cracked seismic stopper at abutment A2. This slightly damaged seismic stopper implies an inclined rather than perpendicular collision between the girder and the seismic stopper because abutment A2 is skewed relative to the direction of traffic flow. Pier P2 was intact (Fig. 23e), whereas pier P1 had obvious damage (Fig. 23f, g) caused by the collision between the girder and the seismic stopper. This collision also resulted in the surrounding concrete flaking off pier P1. Nevertheless, through detailed visual inspection, there were no visible flexural or shear cracks at the bottom of pier P1. The damage to the seismic stoppers (Fig. 23d, f, and g) reflects that the seismic stoppers functioned properly. Figure 23h shows the essentially intact expansion joint at abutment A1. Nevertheless, it is noted that the red traffic markings on the opposite sides of the expansion joint were not in line with each other (Fig. 23h).

**Fig. 23** **a** and **b** Upheavals of the road embankment approaching abutment A2. **c** The damaged noise barriers above the culvert. **d** The cracked seismic stopper at abutment A2. **e** The intact pier P2. **f** and **g** The damaged pier P1. **h** The expansion joint of abutment A1

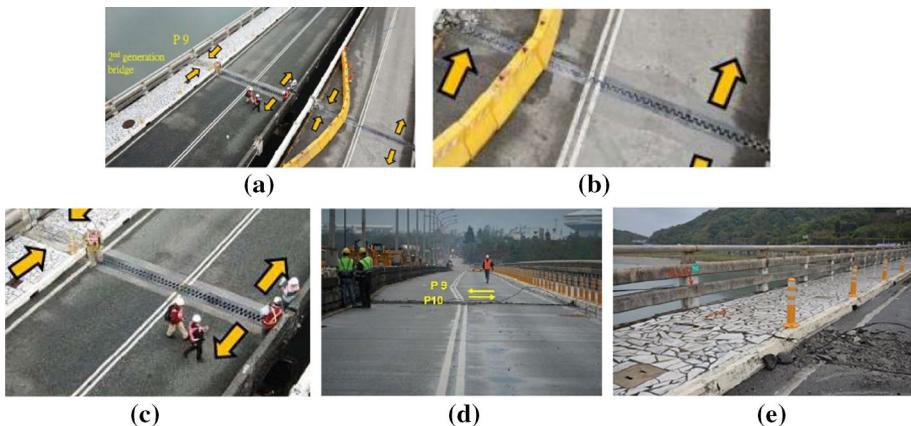
The bridge decks between the expansion joints at piers P9 and P12 were severely damaged. The directions of the yellow arrows in Fig. 25a indicate that the end of the expansion joint at pier P9 of the 2nd-generation bridge (on the side near the 1st-generation bridge) was opened, whereas the other end of the expansion joint was closed. Likewise, the end of the expansion joint at pier P9 of the 1st-generation bridge (on the side near the 2nd-generation bridge) was closed, whereas the other end of the expansion joint was opened. For clarity, Fig. 25b, c, which are magnifications of Fig. 25a, show the expansion joints at pier P9 of the 1st- and 2nd-generation bridges, respectively. From Fig. 21c, the northbound and southbound routes can be viewed as two parallel beams being bent with their tops compressed (i.e., suggesting closed expansion joints) and bottoms tensioned (i.e., suggesting opened expansion joints). Therefore, the non-uniform movements of the expansion joints (Fig. 25a) are consistent with the displacements of the land surface near the Hualien Bridge (Fig. 21c). The deflected white traffic markings between piers P9 and P10 (Fig. 25d) indicate that pier P10 moved northward relative to pier P9, which also reflected

**Fig. 25** **a** Expansion joints at pier P9. **b, c** Magnifications of **a**. **d** Deflected white traffic markings between piers P9 and P10. **e** Shattered bridge deck at pier P10

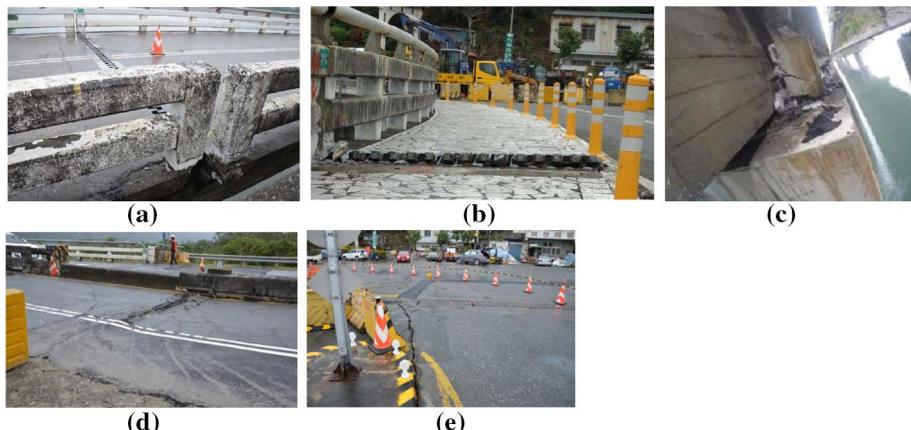
**Fig. 26** **a** Southbound route at pier P12. **b** Northbound route at pier P12. **c** Cracked seismic stopper at pier P12. **d** Upheaval of road surface near abutment A1. **e** Cracked road surface near abutment A2

At the barriers at pier P12 of the southbound route (Fig. 26a), an approximately 15-cm transverse dislocation was observed. Additionally, the teeth of the expansion joint at pier P12 of the northbound route were not only transversely dislocated but also pushed upward (Fig. 26b). Because of the aforementioned transverse dislocation, collision between the girder and the seismic stopper resulted in the crack of the seismic stopper at pier P12 (Fig. 26c). The road surfaces near both abutments A1 and A2 were uplifted and cracked (Fig. 26d, e). This might have been caused by the pushing force of the approach slab of the bridge.

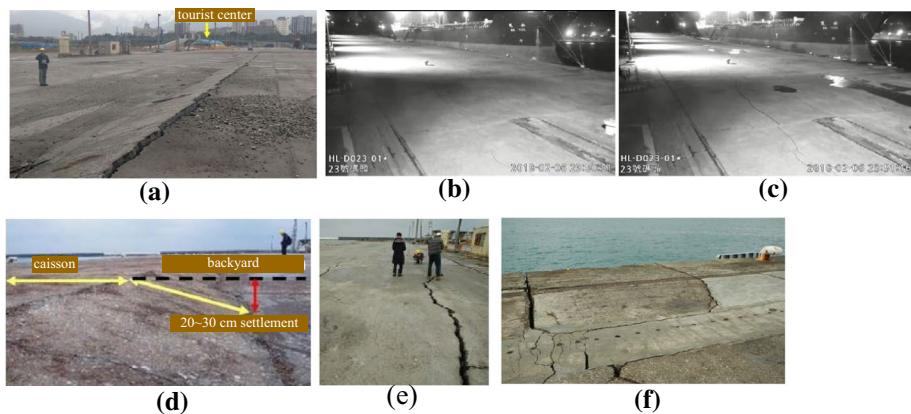
The settlement of back area of wharf No. 23 was approximately 200 mm (Fig. 28a). Besides sands accumulated at some points of wharf No. 23, the border between the caissons and the back area was cracked (Fig. 28a). Nevertheless, the caissons of wharf No. 23 were not damaged, displaced, or settled. Figure 28b, c are images from closed-circuit television (CCTV) installed at wharf No. 23 with recording times at respectively 23:50:51 and 23:51:16 on February 6, 2018. The two recording times, separated by only 25 s, are before and after the strong shaking of the Hualien earthquake. Comparing the two images shows the spurt of underground water and cracks in the pavements caused by the ground shaking. With the CCTV images, the accumulated sands, settlements, and cracks collectively indicate that soil liquefaction happened in this area. The damages to wharf No. 24 shown in Fig. 28d, e were similar to those of wharf No. 23, but the settlement of its back area, which was approximately equal to 200–300 mm (Fig. 28d), was more significant in comparison with that of wharf No. 23. In addition, there was an approximately 90 mm gap between the wave chambers of wharf No. 24 (Fig. 28f) near the turning corner of the wharf, i.e., the side close to wharf No. 25 (Fig. 27b).

**Fig. 28** **a** Accumulated sands and the settlement of the back area of wharf No. 23. CCTV images of wharf No. 23 **(b)** before and **(c)** after the strong ground shaking. **d** The settlement and **e** the crack of the back area of wharf No. 24. **f** The gap between wave chambers of wharf No. 24

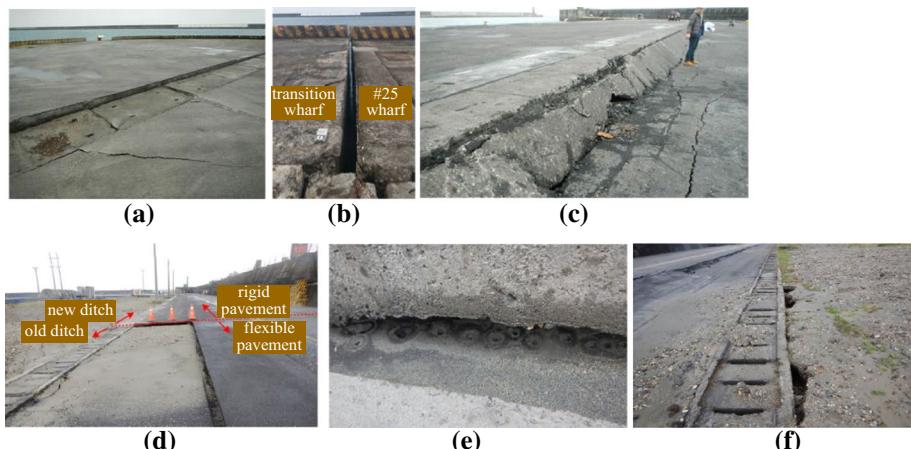
Wharf No. 25 suffered more damage than wharfs No. 23 and No. 24 in this seismic event. A differential settlement appeared on the two sides of wharf No. 25 (Fig. 29a). This earthquake also induced a gap of 80–130 mm between wharf No. 25 and the transition wharf at the turning corner (Fig. 29b). The back area of wharf No. 25 settled to a depth of 500 mm to 600 mm (Fig. 29c). This was the largest settlement among all the wharfs of Hualien Port. Figure 29d–f show images of the western breakwater. Before the Hualien earthquake, parts of the roads on the western breakwater were maintained by repaving roads with rigid pavements instead of the original flexible pavements (Fig. 29d). After the

Hualien earthquake, settlements and cracks occurred in the flexible pavements but not in the rigid pavements. A possible reason for this phenomenon is that the rigid pavements were capable of resisting the settlements induced by hollowing out of the roadbeds, where many sand vents were observed underneath the rigid pavements (Fig. 29e). Figure 29f

**Fig. 29** **a** Differential settlement at wharf No. 25. **b** A gap between wharf No. 25 and the transition wharf. **c** Settlement at the back area of wharf No. 25. **d** The roads, **e** sand vents, and **f** hollowed roads and erupted mixtures on the western breakwater

shows the hollowed roads and the erupted mixtures caused by liquefaction at the western breakwater.

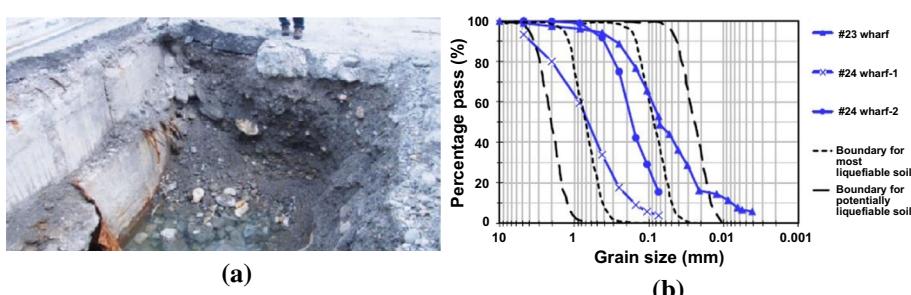
**Fig. 30** **a** Excavated test pit. **b** Accumulation curves for grain sizes

After the earthquake, Hualien Port Corporation excavated some test pits in the back areas to investigate the compositions of the backfill (Fig. 30). The test pits showed that the backfills are mixtures of large-size gravels, sands, and fine particles that are similar to those found in the settled back areas of CentrePort in New Zealand after the Kaikoura earthquake, 2016 (Cubrinovski et al. 2017). The grain sizes of the erupted mixtures during soil liquefaction at wharfs No. 23 and No. 24 were further analyzed (Hsu et al. 2018). Figure 30b shows the accumulation curves for the grain sizes. According to the unified soil classification system (Casagrande 1952), the erupted mixtures collected at wharf No. 23 are classed as ML (Mud, Low plasticity). Additionally, the erupted mixtures collected at two places at wharf No. 24 are classed as SP (Sand, Poorly graded) and SM (Sand, Mud). In addition to the three accumulation curves for the grain sizes, the boundaries for potentially liquefiable and most liquefiable soils suggested by the Ports and Harbors Association of Japan (PHAJ 1999) are also illustrated in Fig. 30b. The diagram shows that all the erupted mixtures during liquefaction collected at wharfs No. 23 and No. 24 were in the range of potentially liquefiable soils (Fig. 30b). Moreover, because all the settlements of the back areas of wharfs No. 23 to No. 25 are less than 700 mm, the seismic damage levels of these wharfs, whose caissons showed no obvious sliding, inclination or structural damage, are categorized as Level I (i.e., useable level) according to the seismic design guidelines for port structures (PIANC 2001).
