Summary of the March 23, 2022 Hualien-Taitung Offshore Earthquake Event

1 - Introduction

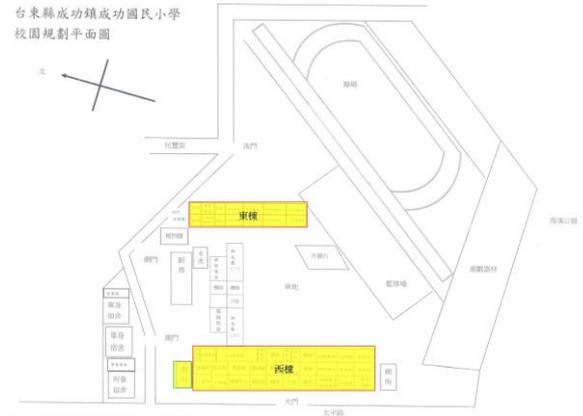
Fig. 14 Layout of CGES.

A stand-alone lavatory (Fig. 14) at Cheng-Gong Elementary School (CGES) in Taitung County located on the north side of the western school building close to the gate was damaged during the earthquake. Because the lavatory is not an area for learning activities, seismic evaluation and retrofit had never been performed. CGES is located 38.9 km from the epicenter of the earthquake (Fig. 15). The PGA recorded by the ChengKung strong ground motion station (1.16 km from the CGES) was about 567 gal (Fig. 16). After the earthquake, the office of the School Seismic Retrofit Project at the NCREE rapidly contacted the responsible person at every county government to collect information on the status of damage of school buildings across Taiwan. The damage to the lavatory was thus reported. Because of a short-column effect, the lavatory sustained shear cracks in the columns with a cover-spalling appearance (Figs. 17 and 18). In contrast, there was no serious structural damage to the eastern and western CGES buildings, which were built in 1988 and 1997, because their
