## Reconnaissance and learning after the February 6, 2018, earthquake in Hualien, Taiwan

### Abstract

**Keywords** Seismic reconnaissance · 0206 Hualien earthquake · Milun fault · Near-fault ground motion · Building collapse · Bridge · Liquefaction · Non-structural component

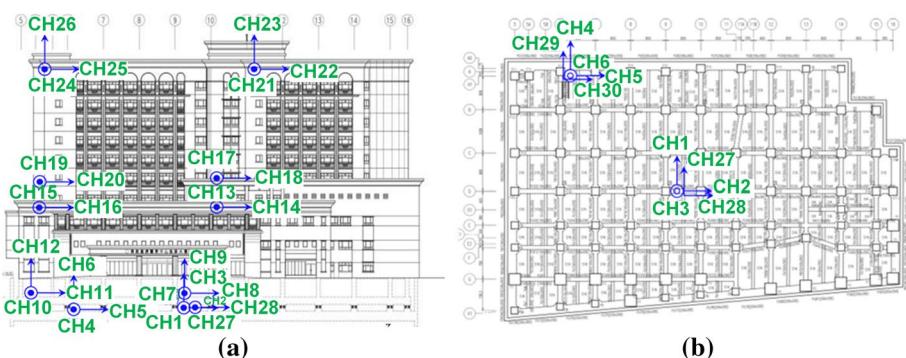
**Fig. 14** Layouts of seismic instruments in **a** elevation and **b** floor plan of B2F

The base-isolated building (Fig. 13a) has been monitored with seismic instruments since the opening of the hospital. Figure 14 shows the layouts of the seismic instruments, including twenty-six channels for accelerometers and four channels for displacement transducers. The four channels for displacement transducers are numbered CH27 to CH30 in Fig. 14b. The other numbered channels shown in Fig. 14 are for accelerometers. Figure 15a–c show the acceleration histories in longitudinal, transverse, and vertical directions, respectively, recorded on the B2F level. In addition, the records obtained from the accelerator located at the center of B2F (i.e., CH1 to CH3) are compared with those obtained from the accelerator located at the corner of B2F (i.e., CH4 to CH6). Figure 15d–f are the counterparts of Fig. 15a–c for the roof's acceleration records. The consistency between the acceleration histories recorded at the centers and corners of the floor plans (Fig. 15) indicates that there were no rotational responses, i.e., there were pure translations in both horizontal directions. These observed pure translations might have two meanings. One is that the building is symmetrical, i.e., it has no plane eccentricities. The other is that the accidental torsion stipulated in modern building codes (e.g., ASCE 2010; Eurocode-8 2003; CPAMI 2011)

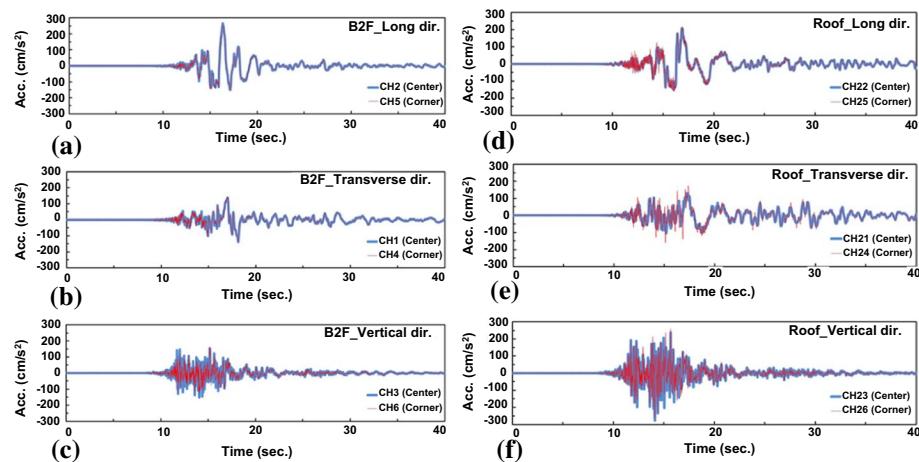
**Fig. 15** Acceleration histories recorded at B2F in the **a** longitudinal, **b** transverse, and **c** vertical directions, and recorded at the roof in the **a** longitudinal, **b** transverse, and **c** vertical directions

Figure 15 also shows that the values of the longitudinal, transverse, and vertical peak accelerations are 209, 131, and 279 cm/s<sup>2</sup>, respectively, at the roof's center (Fig. 15d–f), and 266, 139, and 155 cm/s<sup>2</sup>, respectively, at the center of B2F (Fig. 15a–c). Therefore, the ratios of the longitudinal, transverse, and vertical peak accelerations recorded at the roof's center to those recorded at the center of B2F are 0.79, 0.94, and 1.8, respectively. In other words, the percentages of the reduced accelerations in the longitudinal and transverse directions were 21% and 6%, respectively, whereas the acceleration in the vertical direction increased by 80%. The acceleration response spectra corresponding to the ground motion records of strong motion station HWA019 (Fig. 5b) indicate large acceleration demands for structures with vibration periods of 2 to 4 s. Because both the designed first vibration periods in the longitudinal and transverse directions of this building (Fig. 13a) are 2.76 s, it is expected that the effect of the base isolation used in this building on reducing the peak accelerations was not significant in this seismic event. This unremarkable seismic performance of the base isolation indicates that the effect of near-fault ground motions on base-isolated buildings should be properly and thoughtfully considered. Moreover, it is clear that LRBs isolate horizontal ground accelerations rather than vertical ground accelerations. Therefore, considering that the vertical vibration period is very short, the 80% increment of the peak vertical acceleration of the roof in comparison with that of B2F appears reasonable.

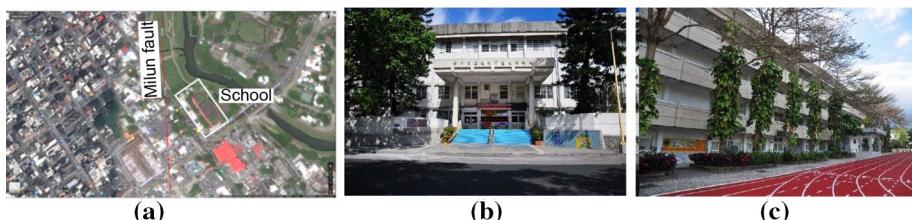
**Fig. 17** **a** Map showing a school close to the Milun Fault. **b** Central front and **c** overall views of the school building

Figure 17a shows an elementary school close to the Milun Fault. The school has only one building, which has four stories and one basement floor constructed in 1990. This school building was retrofitted with enlarged columns, added shear walls, and wing walls

in 2011. Even though this school building is close to the Milun Fault, no structural damages were found in the building (Fig. 17b, c). Moreover, it is worth mentioning that two retrofitted buildings of a junior high school were intact during the 2016 Meinong earthquake. In contrast, two other buildings of the same school that had not been retrofitted at the time of the 2016 Meinong earthquake suffered obvious damages in that seismic event (Henry et al. 2017; Shen et al. 2016). Therefore, in addition to the aforementioned case of the 2016 Meinong earthquake, the results of the reconnaissance demonstrate again that the project of seismic evaluation and retrofitting of school buildings across Taiwan initiated in 2009 was quite successful.

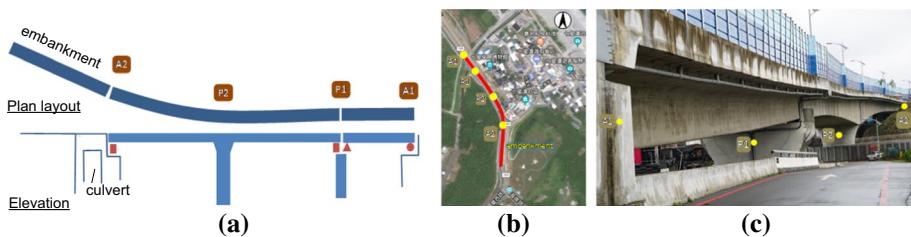
**Fig. 22** Qixingtan Bridge: **a** diagrams of the plan and elevation layouts, **b** satellite image, and **c** photograph

Figure 22a depicts a plan and elevation layouts of Qixingtan Bridge, which was opened for traffic in 2013. Abutment A1 to pier P1 is a 60-m-span simply supported vibration unit where the bearing at abutment A1 is longitudinally moveable and the bearing at pier P1 is a hinge. Pier P1 to abutment A2 is another vibration unit that is a two-span, 90 m + 90 m, continuous girder rigidly connected to pier P2 (Fig. 22a). In this two-span vibration unit, both the bearings at pier P1 and abutment A2 are moveable in the longitudinal direction and fixed in the transverse direction, and vertically adjustable. Abutment A2 is skewed relative to the direction of traffic flow. The superstructure of the bridge consists of

pre-stressed concrete two-cell box girders. The substructure of the bridge is single-column RC piers with elliptical cross-sections and pile foundations. In addition, there is a culvert integrated with abutment A2 (Fig. 22a). Figure 22b, c show respectively a satellite image and a photograph of the Qixingtan Bridge. The serial numbers of the piers and abutments are marked in the photographs (Fig. 22b, c).

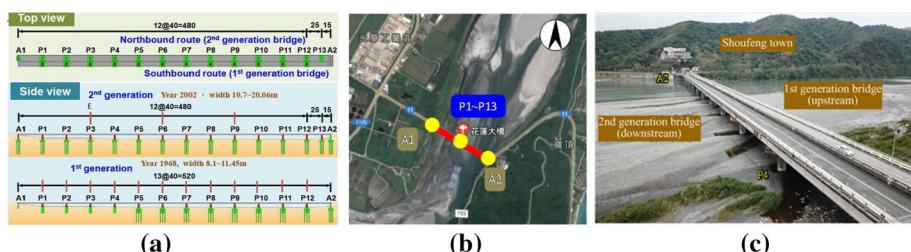
**Fig. 24** a Top and side views, b satellite image, and c photograph of Hualien Bridge

Figure 24a depicts top and side views of the Hualien Bridge, whose structures for the northbound and southbound routes are completely separated. The southbound and northbound routes, completed in 1968 and 2002, respectively, are designated as 1st- and 2nd-generation bridges (Fig. 24a). Both the 1st- and 2nd-generation bridges were seismically retrofitted in 2013. Figure 24b, c show the satellite image and a photograph of the Hualien Bridge, respectively. Figure 24a indicates the span layouts and the bridge widths. Each span of the 1st-generation bridge consists of simply supported pre-stressed I-shaped girders sitting on neoprene pads. Expansion joints are set between every two spans of the bridge. The substructure of the 1st-generation bridge consists of circular single-column piers supported by circular caissons. Additionally, the foundations of piers P5 to P12 were retrofitted with extended pile caps and added piles in 2013 (Fig. 24a). The layout of the 2nd-generation bridge is similar to that of the 1st-generation bridge except that the former has no caissons but only piles. Besides abutments A1 and A2, the expansion joints of the 2nd-generation bridge are installed only at piers P3, P6, P9, P12, and P13 (Fig. 24a). The hinge-connected bridge decks are above the other piers where expansion joints are not installed. The 2nd-generation bridge was retrofitted with enlarged RC piers and added piles in 2013.

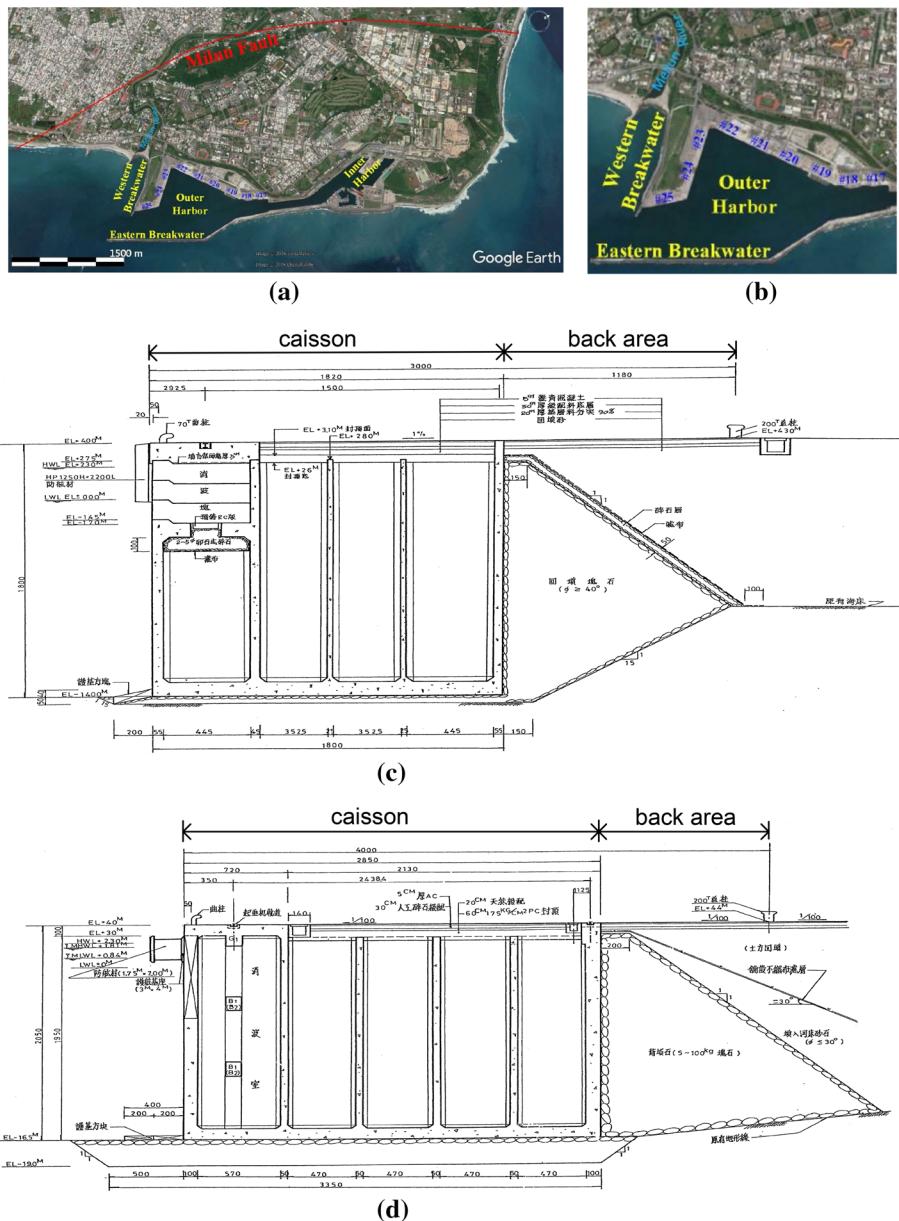
**Fig. 27** Hualien port: **a** satellite image, **b** magnification of **a**, **c** cross-section of wharfs No. 23 and No. 24, and **d** cross-section of wharf No. 25

Significant liquefaction was observed at Hualien Port. Figure 27a shows the location of Hualien Port relative to the Milun Fault. Hualien Port consists of inner and outer harbors with 25 deep-water wharfs. Wharfs No. 1 to No. 16 and wharfs No. 17 to No. 25 are located in the inner and outer harbors, respectively. The outer harbor was completed in the final stage of an expansion project in 1991. The major liquefaction occurred at wharfs No. 23 to No. 25 as well as the western breakwater. Figure 27b, magnified from Fig. 27a, shows the locations of wharfs No. 17 to No. 25. Because the direction of wharf No. 25 is approximately 135° clockwise from the direction of wharf No. 24 (Fig. 27b), there is a transition wharf at the turning corner, i.e., between wharfs No. 24 and No. 25. Figure 27c, d show the cross sections of the gravity-type caissons of wharfs Nos. 23 and 24 and wharf No. 25, respectively. The back areas of the caissons shown in Fig. 27c, d were backfilled with gravels and sands.
